**DEPARTMENT OF TRANSPORTATION****DIVISION OF ENGINEERING SERVICES**

Contract #: 04-0120F4Cty: SF/ALA Rte: 80 PM: 13.2/13.9File #: 99.28**WELDING INSPECTION REPORT****Resident Engineer:** Casey, William**Address:** 333 Burma Road**City:** Oakland, CA 94607**Report No:** WIR-029940**Date Inspected:** 23-Aug-2013**Project Name:** SAS Superstructure**OSM Arrival Time:** 600**Prime Contractor:** American Bridge/Fluor Enterprises, a JV**OSM Departure Time:** 1530**Contractor:** Steward Machine Co.**Location:** Birmingham AL**CWI Name:** Fred Hudson**CWI Present:** Yes No**Inspected CWI report:** Yes No N/A**Rod Oven in Use:** Yes No N/A**Electrode to specification:** Yes No N/A**Weld Procedures Followed:** Yes No N/A**Qualified Welders:** Yes No N/A**Verified Joint Fit-up:** Yes No N/A**Approved Drawings:** Yes No N/A**Approved WPS:** Yes No N/A**Delayed / Cancelled:** Yes No N/A**Bridge No:** 34-0006**Component:** E2 Shear Key Anchorages**Summary of Items Observed:**

## WELDING INSPECTION REPORT

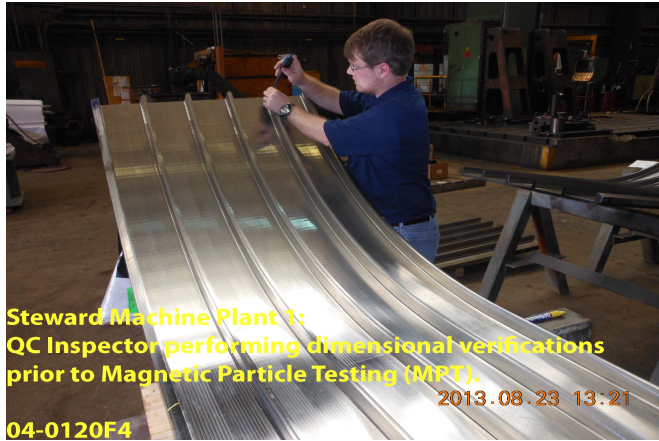
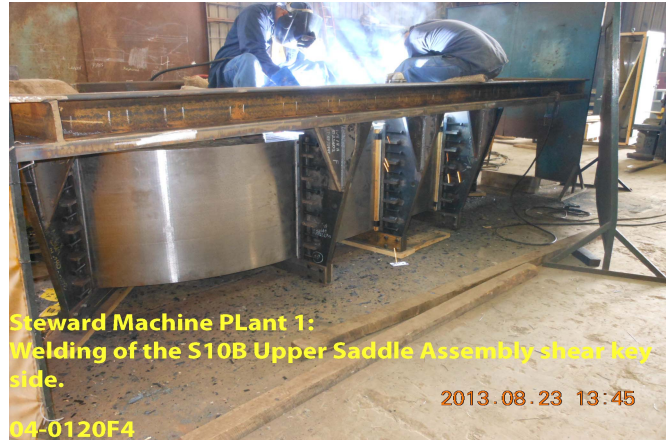
Upper Saddle Assembly S10B as welded by welders #73 and #476 above includes plates S10B-d1, S10B-c1, S10B-b1, S10B-a1, S10B-b2, S10B-a2.
